Key Messages from a Decade of Water Quality Research into Roof Collected Rainwater Supplies

*Peter J Coombes, Hugh Dunstan, Anthony Spinks, Craig Evans and Tracy Harrison
School of Environment and Life Sciences, University of Newcastle
Callaghan, 2308, Australia. p.coombes@newcastle.edu.au*

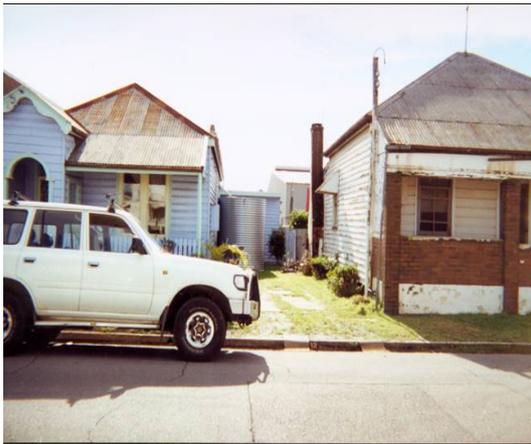
Figure 2: The Maryville House

Using the lessons learnt from the Figtree Place project, an old house in Maryville, a neighbouring inner city suburb of Newcastle was fitted with a large above ground 9.1 kL Aquaplate™ rainwater tank to supply hot water, toilet and outdoor uses to the three person household (Figure 2) (Coombes et al., 2003). An efficient dual water supply system was created that allowed the tank to be topped up with mains water to a minimum water level whenever rainwater supplies were low (Figure 3). This system eliminates the risk of backflow of rainwater into mains water supplies and ensures that water is always available. The average annual mains water savings provided by the tank was 52kL/annum.

Similar to the Figtree Place project, the Maryville House is located adjacent to Newcastle's heavy industrial area and the industrial highway. The site is subject to high levels of industrial and urban pollution. Unlike the Figtree Place project, the house has a rusty galvanised iron roof, an instantaneous gas hot water system that was set at 55°C and no first flush device. Average values for water quality at different locations in the rainwater treatment train are shown in Table 2.

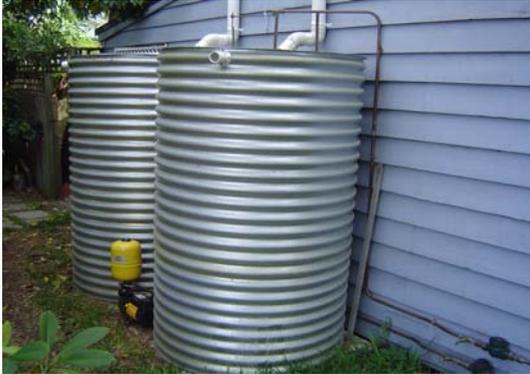
Figure 4: Picture of rainwater tanks

A third rainwater harvesting system was installed at Carrington, an inner city suburb located in the docklands within the industrial area of Newcastle. Two small rainwater tanks (2.1 kL each) with a mains water top up scheme are used to supply all water uses to the two person household (Figure 4). The mechanical top up system relies on vertical movement of the float valve to top up the tank to a minimum level at a variable rate dependent on the water depth in the tank (Figure 5).
