Chapter 2

The Figtree Place Experiment

2.0 Introduction

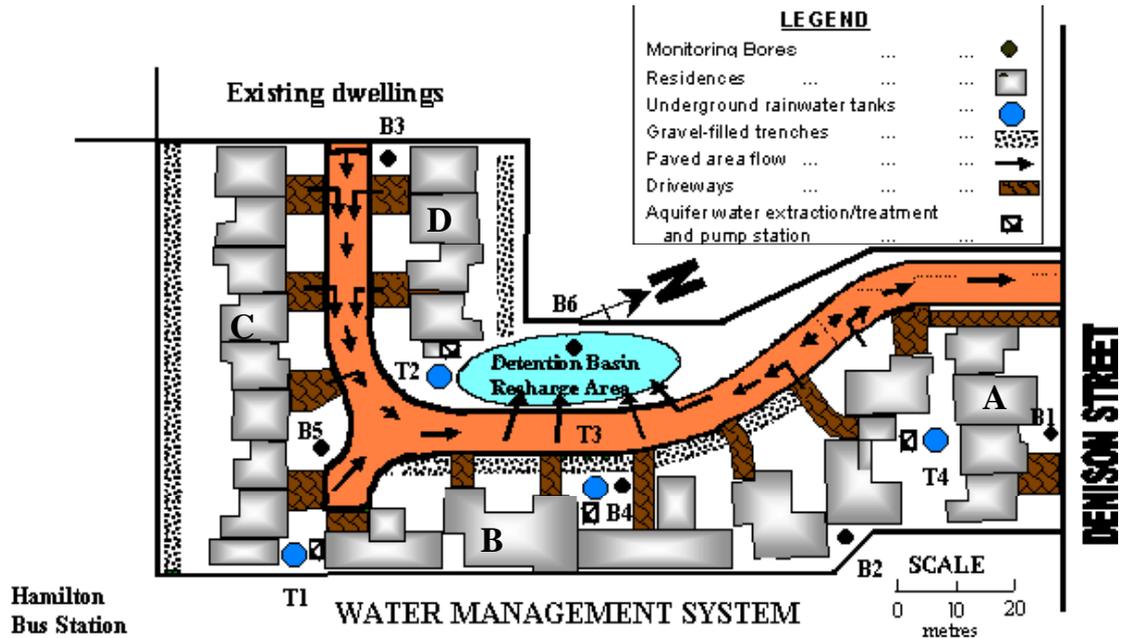
The water sensitive design elements at Figtree Place include underground rainwater tanks, gravel filled trenches (soakaways), a recharge basin and a submerged pump in the aquifer. A

general plan of the site and the water sensitive design elements is shown in Figure 2.1.

Figure 2.1: General plan and water sensitive design elements of Figtree Place

Stormwater runoff from paths, lawns and gardens is directed into the detention basin via internal roadways (Figures 2.1 and 2.2). Stormwater is then recharged to the aquifer from the detention basin. Groundwater is supplied using a submerged pump for irrigation on site and bus washing at the Hamilton Bus Station.

Pumps with pressure vessels are situated in pump houses adjacent to each rainwater tank (Figure 2.1). Each pump house has a number of fail-safe water supply systems. These include a second pump to operate in case of pump failure and a solenoid that switches water supply from tank water to mains supply if inadequate water pressure is detected, electricity supply is interrupted, or if a low water level is detected in a rainwater tank. The provision of an additional pump at each tank was a conservative and unnecessary measure motivated by the approval authority's concern about the reliability of rainwater supplies. Pump failure was not a critical issue at the Figtree Place because each unit was supplied with mains water in the advent of pump failure.

An automated sampling site was established at a pump house adjacent to the western rainwater tank (shown as T2 in Figure 2.1). The site (Figure 2.2) uses a data logger, a tipping bucket rain gauge, pressure sensors, a water quality monitor and a refrigerated water quality sampler. The data logger controls monitoring and recording processes according to the flowchart shown in Figure 2.6.

Pressure sensors were used to measure water levels in the first flush pit (Figure 2.3), in rainwater tanks (Figure 2.4) and in groundwater bores (B1-B6 in Figure 2.1). Pressure sensors were also placed in a small pit with a grate cover in the recharge basin (Figure 2.5) to measure ponding and in a slotted pipe standing upright within the gravel layer in the recharge trench to measure infiltration. The water quality monitor measures temperature, pH, DO, conductivity, turbidity and salinity of the water in the rainwater tanks.

supplying rainwater to unit block D (Figure 2.1) was continuously monitored. Figure 2.11 shows the maximum tank water level and rainfall depth for each day from 27/04/99 until 14/08/00.

The groundwater levels immediately under the infiltration basin (Bore 6) shown in Figure 2.13 do not discriminate between the regional and local response of groundwater levels to rainfall depth. In order to determine the effect of the infiltration measures on the aquifer below Figtree Place the groundwater levels at a number of bores (Bores 1 – 6 shown as B1 – B6 in Figure 2.1) are shown in Figure 2.14.

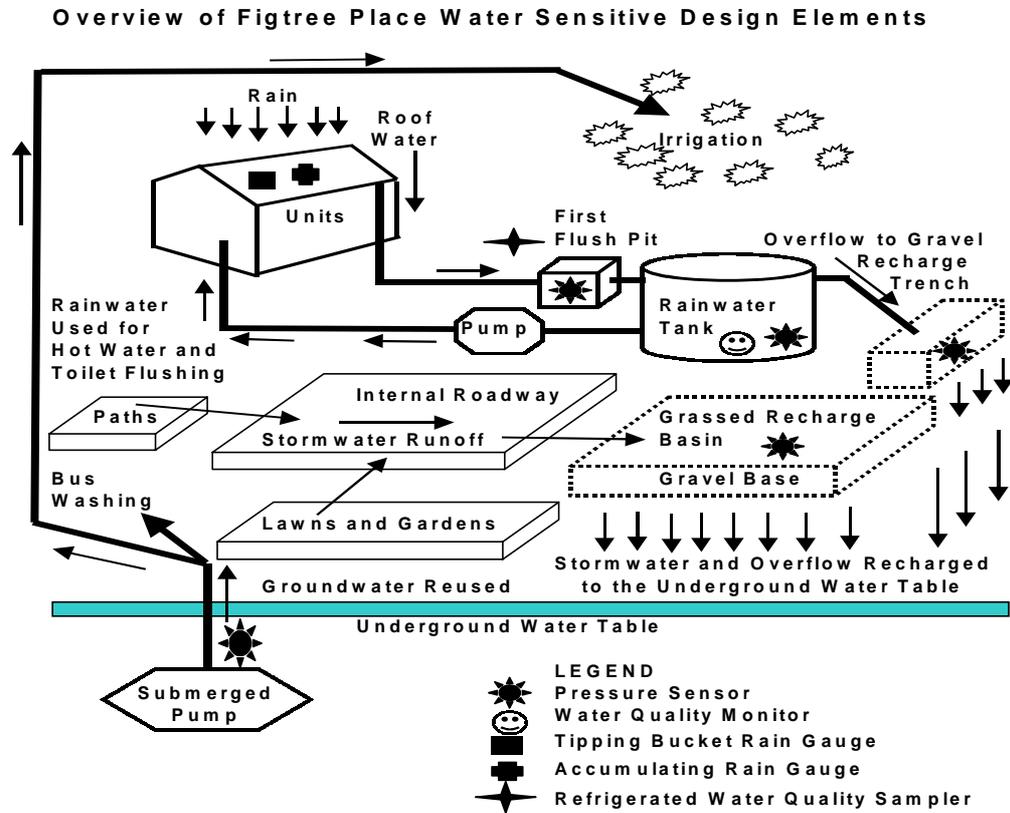
The Figtree Place water sensitive design concept is detailed in Figure 2.2. Rainwater collected from roofs flows via stormwater pipes through a first-flush pit into a rainwater storage tank. Pumps with pressure cells supply rainwater from tanks for use in hot water systems and for toilet flushing. If a rainwater tank's capacity is exceeded overflow is directed to a gravel trench and recharged to the aquifer.

Figure 2.2: The Figtree Place Water Sensitive Design Concept

Stormwater management at Figtree Place is dependent on a central infiltration basin, rainwater tanks and infiltration trenches. Stormwater runoff from paved surfaces and lawns is directed to a central infiltration basin and overflow from the rainwater tanks is collected in infiltration trenches subsequently percolating to an unconfined aquifer (Figures 2.1 and 2.2).

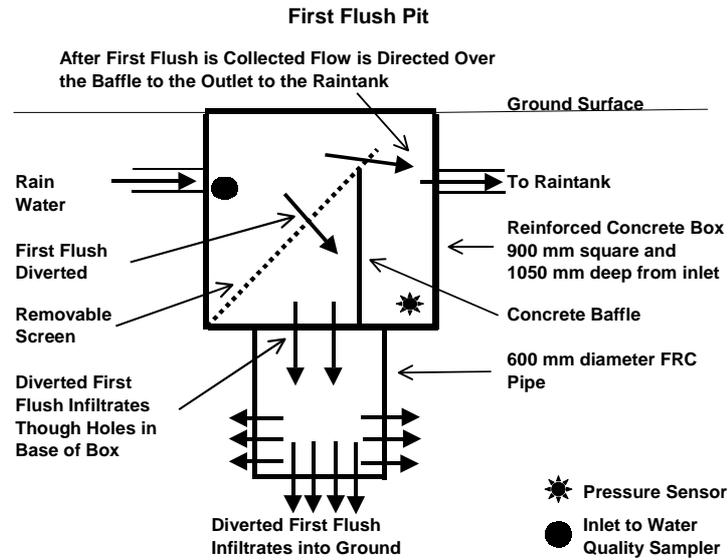
The first-flush pit (Figure 2.3) was designed to separate an initial portion of roof runoff containing higher concentrations of pollutants from inflow to rainwater tanks. There is limited research on defining the quantity of first flush separation producing acceptable water quality in rainwater tanks. Jenkins and Pearson [1978] suggest separating the first 0.25 mm of rainfall for a typical sized household roof. First flush pits at Figtree Place were conservatively designed to divert the first 2 mm of rainfall from the inflow to the rainwater tank due to a concern that industrial fallout on roofs and subsequent wash off would

First-flush pits were constructed using a reinforced concrete box placed over a fibre reinforced concrete pipe. The concrete box contains a screen to filter debris from the roofwater flow and a baffle to separate first flush from inflow to the rainwater tank. Roofwater retained upstream of the baffle infiltrates through holes in the base of the box to the pipe and into the soil.

Figure 2.3: Diagram of a first flush pit

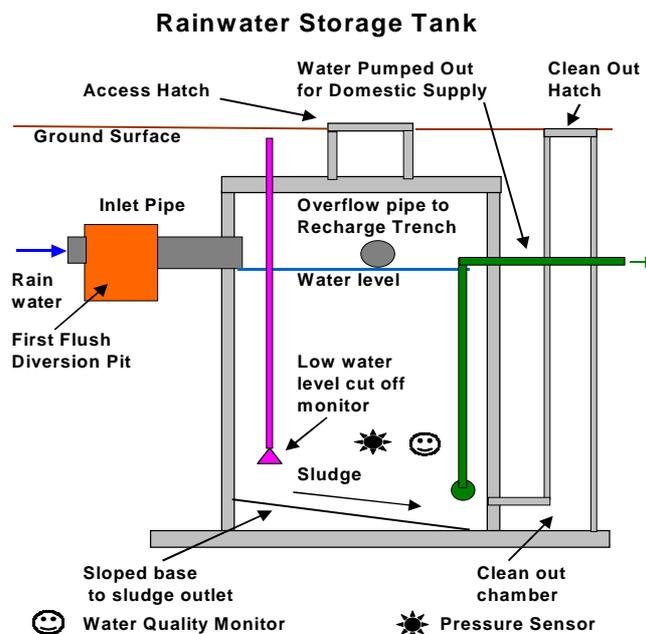
Reinforced concrete rainwater tanks (Figure 2.4) are used at Figtree Place. The four rainwater tanks are rectangular with capacities ranging from 10 kL to 20 kL. Rainwater tanks contain an inlet from a first flush pit, a clean out chamber for removal of sludge, a low water level monitor, an outlet for domestic supply and an overflow pipe to a recharge trench. The low water level monitor allows water to be drawn from mains supply if the water level in a tank is low.

Figure 2.4: Diagram of a rainwater storage tank

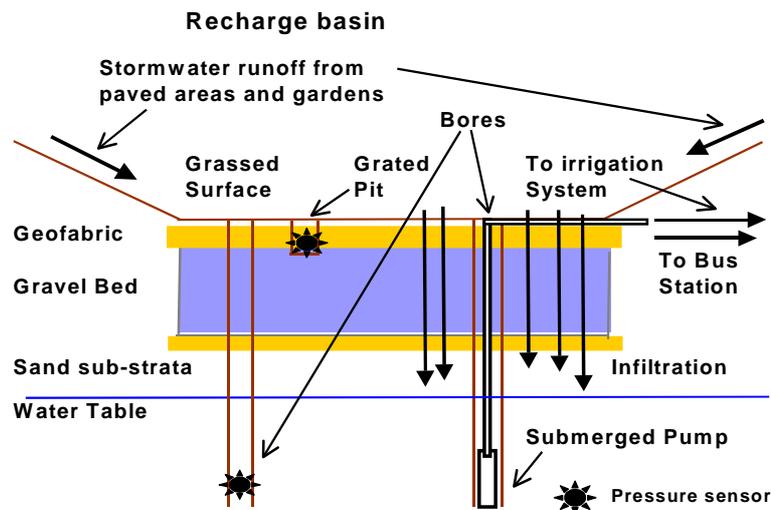
The recharge basin (Figure 2.5) is a grassed depression with an area of 300 m² that overlays a 750 mm layer of gravel enclosed in geofabric. All surface stormwater runoff is directed to

the basin and the high infiltration rates of the sandy soil are exploited to minimise overflows from the basin. The infiltration basin was designed to prevent stormwater overflows to Denison Street up to the 50-year average recurrence interval (ARI) storm event. A submerged pump supplying groundwater for irrigation and bus washing is situated within the recharge basin at a depth of 10 metres.

Figure 2.5: Diagram of the recharge basin

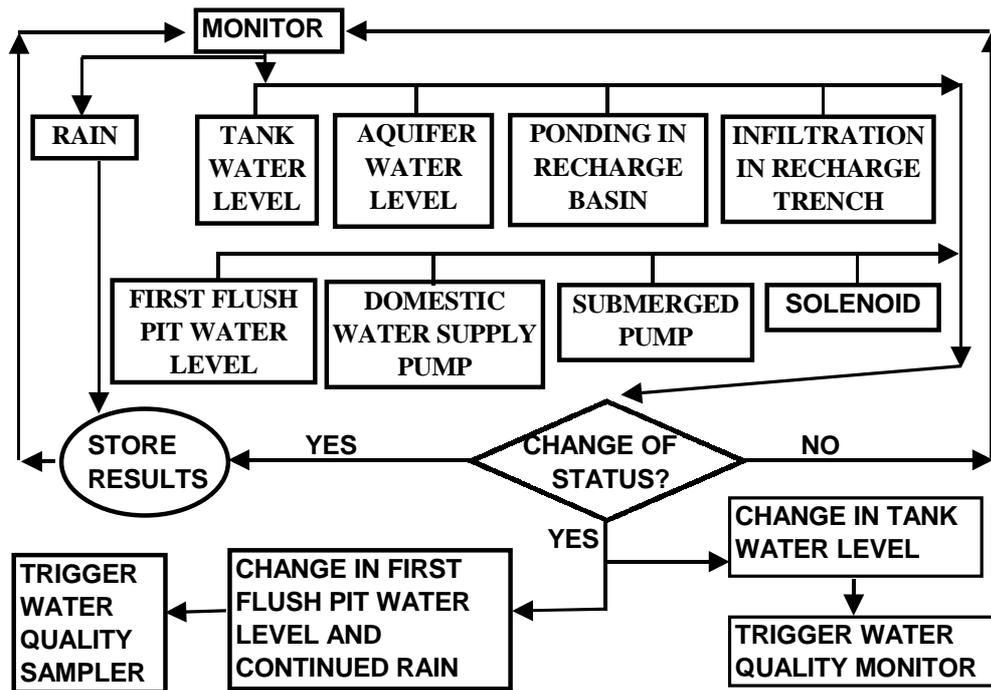
Figure 2.6: Automated monitoring flowchart

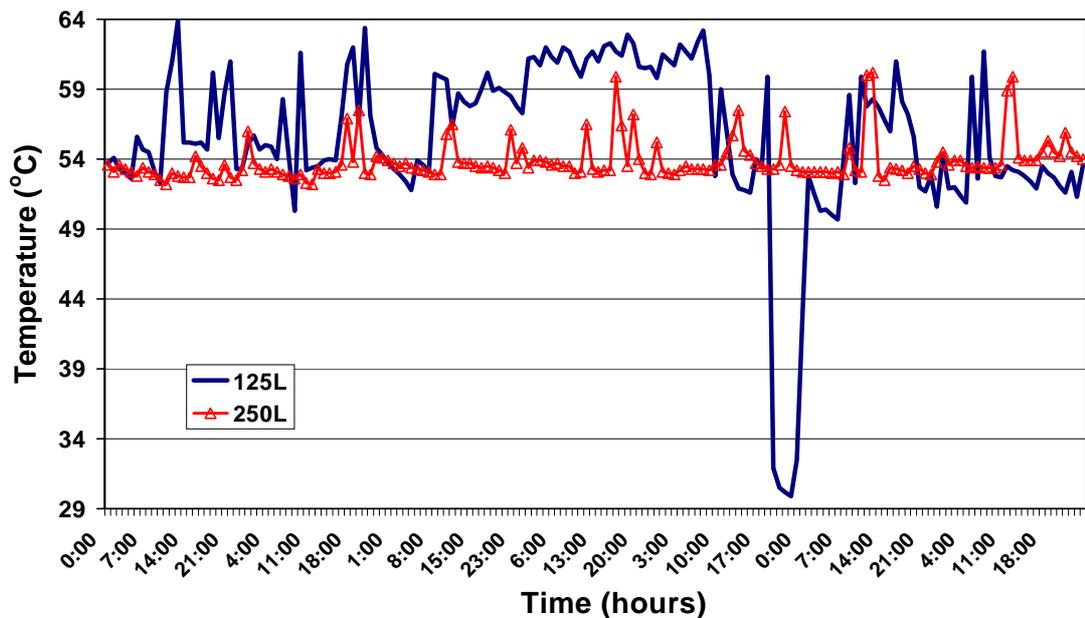
Monitoring of hot water systems to determine temperatures and operating conditions that may produce bacterial compliance with the Australian Drinking Water Guidelines [NHMRC 1996] was established. Water temperatures from hot water systems with different capacities and operating conditions were measured over a long period. The results from two hot water systems during one week are shown in Figure 2.7.

Figure 2.7: Water temperatures from two different hot water systems over a period of a week

The temperature range of an electric 125 litres capacity hot water system set at 60°C that supplies hot water at an off-peak rate to a two person household is shown as 125 L in

Figure 2.7. The off-peak rate heats water from 6 AM to 8 AM and from 8 PM to 10 PM. The average operating temperature was found to be 56°C, the maximum temperature 64.5°C and the minimum temperature 30°C. The low temperature of 30°C resulted from a change in washing mode from showers to a full bath by one of the occupants on one occasion. The capacity and operating mode of the hot water system was insufficient to maintain hot water supply within a temperature range that appears to allow bacterial compliance with guidelines. Removal of the bath event from the data gives a minimum operating temperature of 50.1°C.

The temperature range of an electric 250 L hot water system set at 55°C that supplies hot water at an off-peak two rate to a four person household at Figtree Place is shown as 250 L in Figure 2.7. This hot water system is a component of each unit at Figtree Place. The average operating temperature was found to be 53.7°C, the maximum temperature 60.2°C and the minimum temperature 51.8°C. This hot water system was operating within the range of temperatures that is expected to produce compliance with the drinking water guidelines.

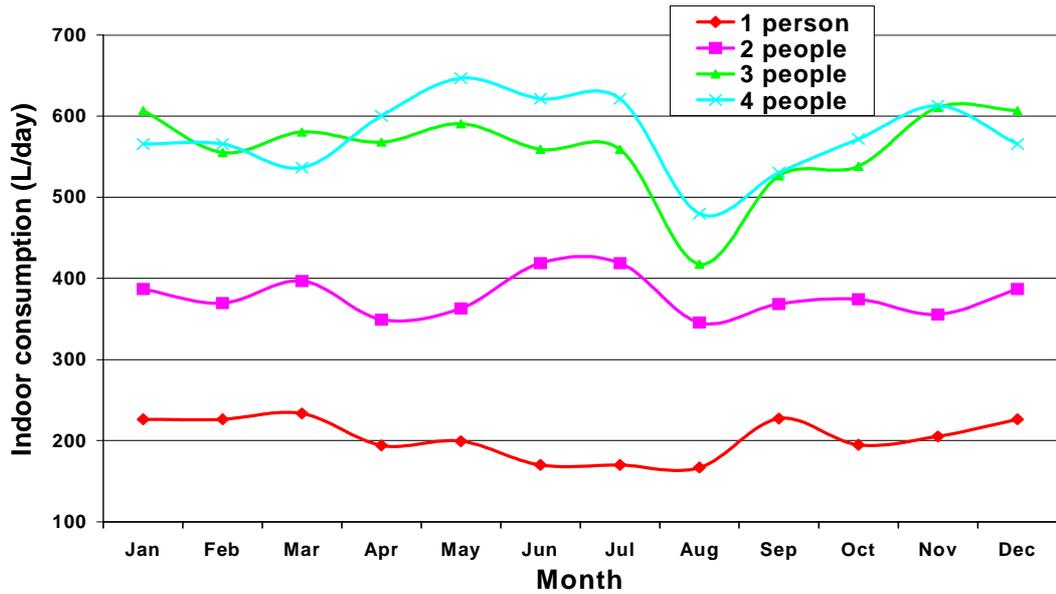
Table 2.11 shows that water consumption at Figtree Place varies from month to month and with the number of occupants. The variation and patterns in water consumption are shown in Figure 2.8. The hot water and toilet use proportion of consumption also varies by number of occupants and from month to month.

Figure 2.8: Monthly daily average indoor water consumption for different numbers of occupants at Figtree Place

The monthly indoor water use patterns and volumes are shown to be similar for three and four person dwellings and significantly different for single and two person dwellings. The monthly daily average indoor water use at Figtree place and from 130 dwellings monitored in the Lower Hunter region by HWC [B. Berghout, personal communication, 1999] is compared in Figure 2.9.

In Figure 2.8 it is shown that the average indoor water use for units with 3 and 4 occupants was significantly lower in August than in the surrounding months. This trend is reflected in the overall average indoor water use (Figure 2.9) in August for Figtree Place. The reduced water use in August appears to be caused by families leaving the Figtree Place for the school holidays. Units with 3 or 4 occupants usually contained school age children.

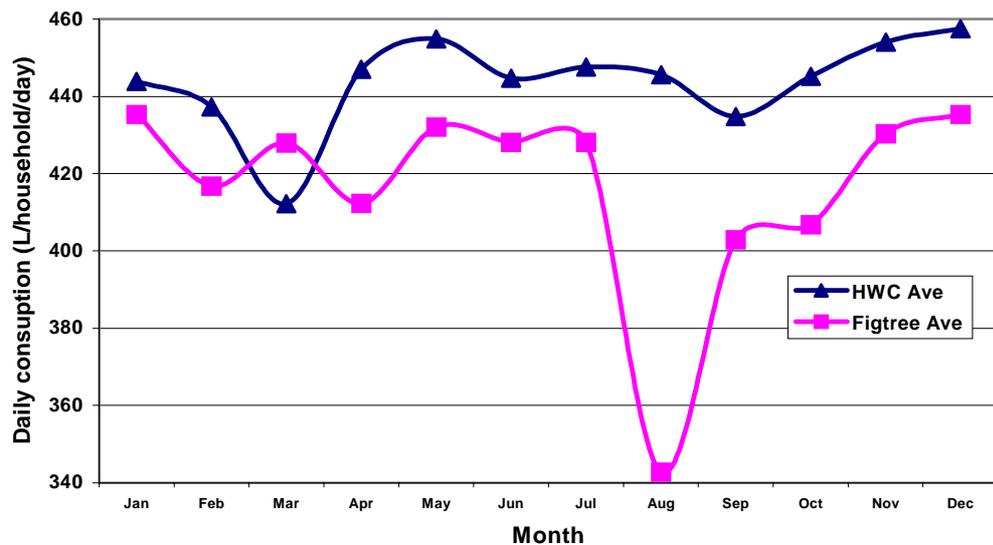
Figure 2.9: Monthly daily average indoor consumption for Figtree Place and the Lower Hunter region

The average water consumption per dwelling at Figtree Place (417 L/day) is less than the

average water consumption in the Lower Hunter region (444 L/day). Figtree Place also has different consumption patterns than the Lower Hunter region (Figure 2.9). The different consumption patterns are likely to be the result of different population profiles. Only people with low incomes are permitted to occupy dwellings at Figtree Place. As a result families with young children dominate the occupation of dwellings at Figtree Place. These are mostly single parent families that rely on casual employment. When the parents leave the development to attend employment the children also leave the site to be cared for by relatives or day care centres. It is believed that the lower average indoor water use results (Figure 2.9) for the Figtree Place development is due to the frequent absences of parents and children from the site.

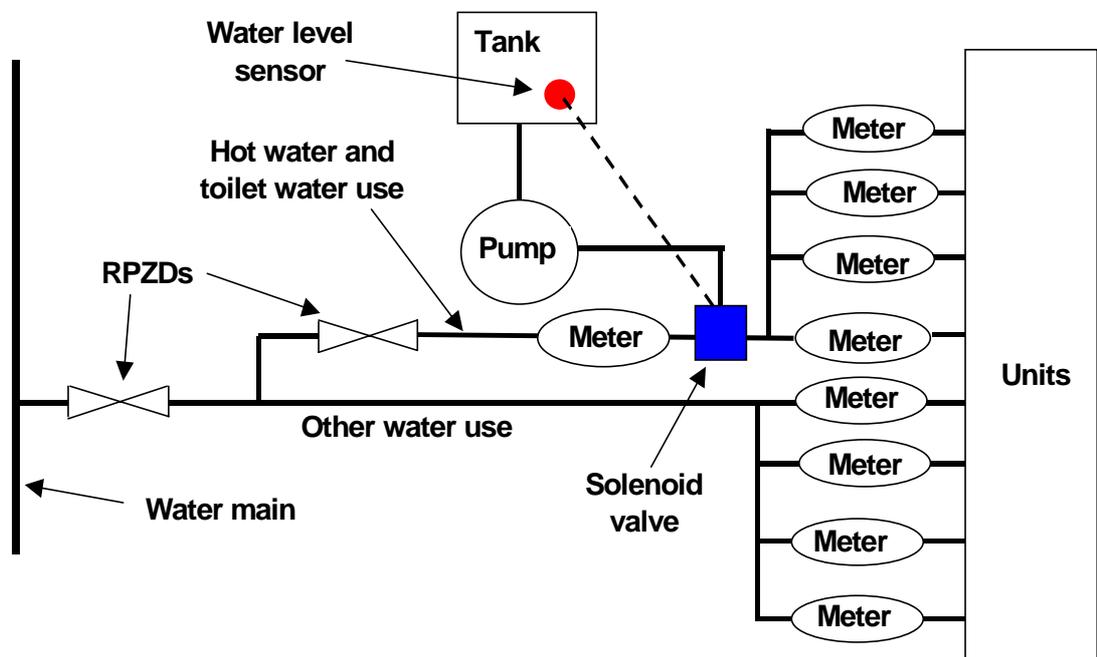
Water use from the four rainwater tanks at Figtree place was determined by meter readings at each unit and at each tank. Two water meters were installed at each unit. One meter measures hot water and toilet use, and the other measures all other indoor water use. The water meter at each rainwater tank records mains water used to supply hot water and toilets when rainwater was not available from the tank. A schematic of the plumbing and metering system is shown in Figure 2.10.

Figure 2.10: A schematic of the plumbing and metering system at Figtree Place

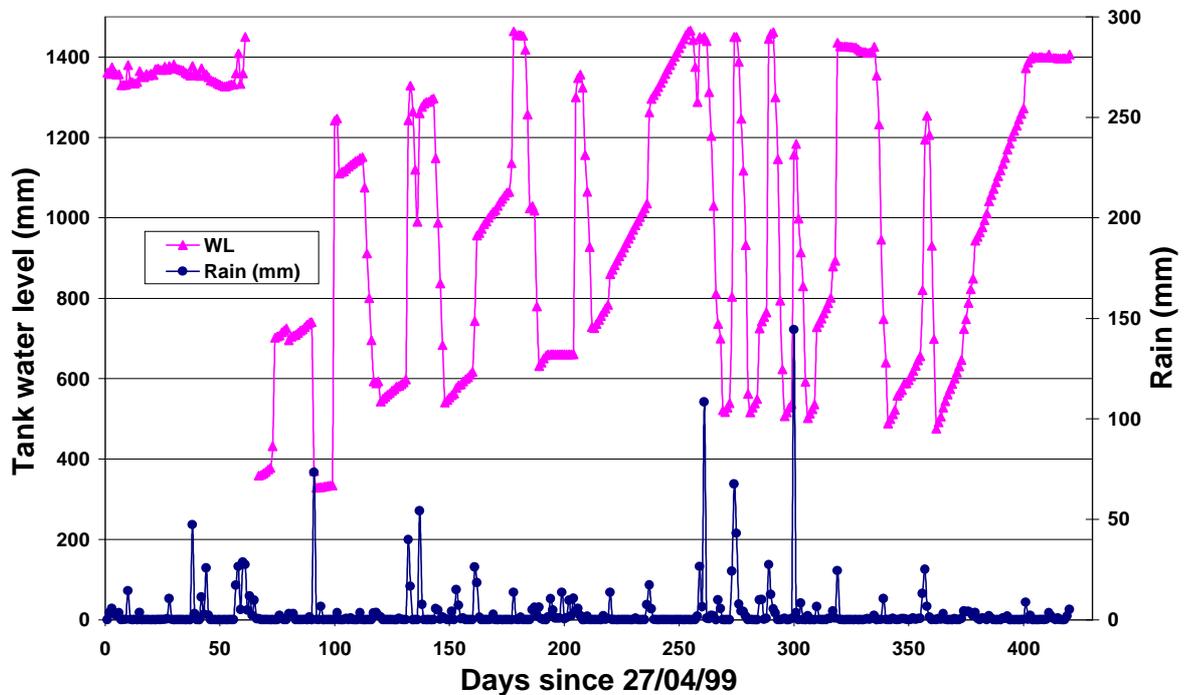
Figure 2.11: Daily water levels and rainfall at Figtree Place tank T2

Water levels in tank T2 are shown in Figure 2.11 to be constant on many days with no rainfall during the monitoring period. Unit block D consists of four units with a total of eleven occupants whose hot water and toilet water use was about 1050 Litres per day and the tank capacity was 8.9 m³. Failure of the tank water level to be constantly drawn down indicated that the tank was often not in use. Water use from the tank was calculated using the monitoring results for rainfall and tank water level. Rainfall and tank water use were compared in Figure 2.12 in order to locate a period where the rainwater system was operating without interruption.

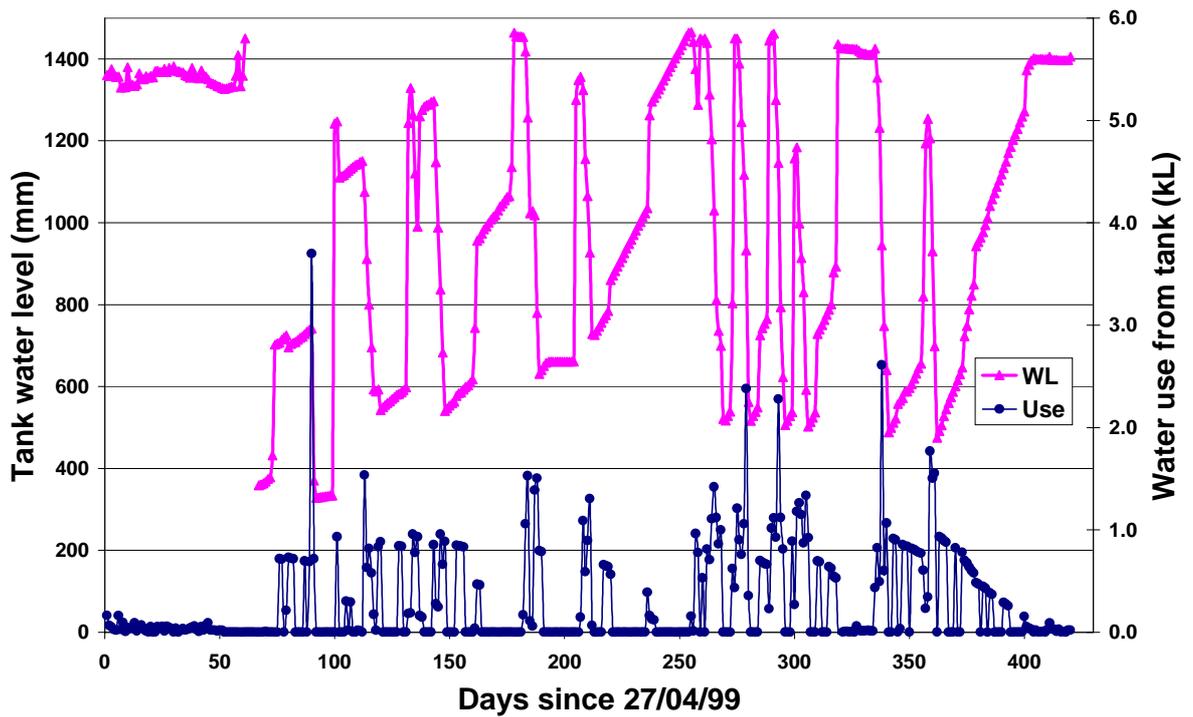
Analysis of Figure 2.12 indicates that the rainwater system at tank T2 was likely to be operating without interruption during the period from 2/03/00 to 14/04/00 (shown as day number 256 to 307 in Figure 2.12). Water balance calculations for that period indicated a 40% reduction in mains water use although meter readings for the same period showed a 33% reduction in mains water use.

Figure 2.12: Daily water levels and water use from the Figtree Place tank T2

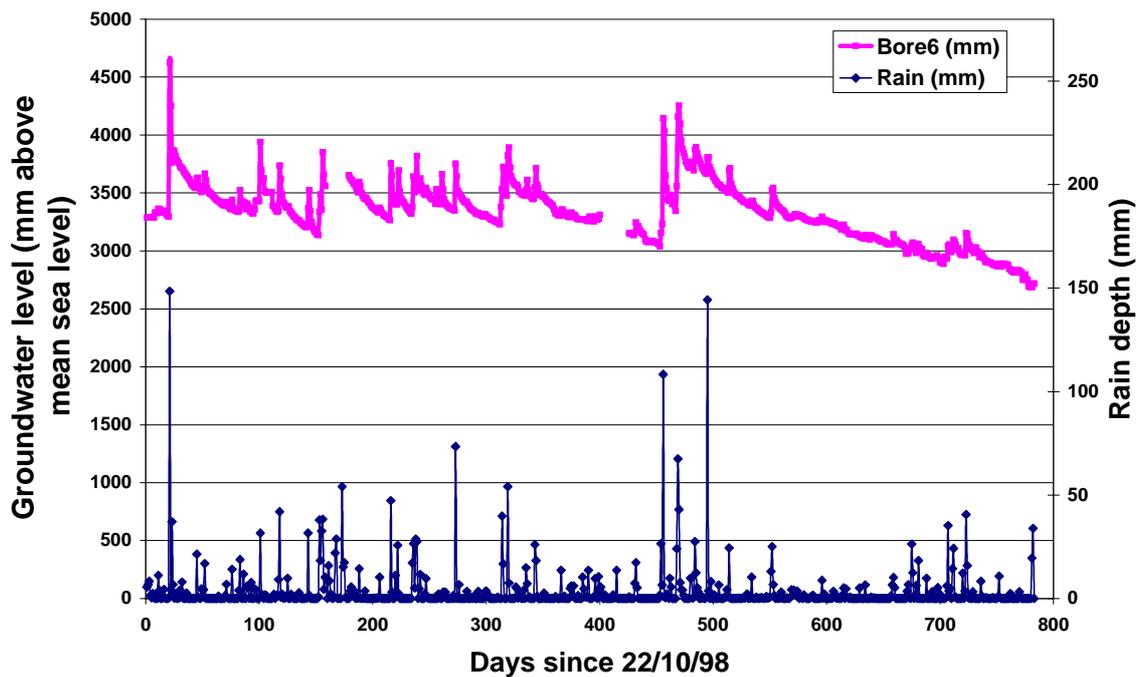
The irrigation and bus washing schemes using groundwater from the Figtree Place site were subject to intermittent operation. Similar to the rainwater use scheme, operation of the groundwater use scheme was limited by construction errors, reconstruction and interference. A HWC plumber frequently diverted the bus-washing scheme from groundwater to mains water supply. The performance of the infiltration basin and the aquifer levels were monitored to assess a “worst case” scenario where the majority of stormwater was infiltrated to the aquifer with very little groundwater used for bus washing or irrigation. The height of the water table (in mm above mean sea level) immediately below the infiltration basin is shown in Figure 2.13.

Figure 2.13: Height of the water table below the central infiltration basin

Figure 2.13 reveals that the groundwater levels (shown as Bore 6 in Figure 2.13) varied with rainfall depth during the life of the project. This is highlighted by the steady decline in groundwater level in response to a decreased rainfall depth after day number 500. The results also show that the groundwater level did not approach the ground surface level at the invert of the infiltration basin (6000 mm) during the monitoring period suggesting that no unacceptably wet conditions were created in backyards or gardens and unit footings were not adversely affected. In fact on only one occasion did the water table come within 1.5 m of the ground surface in the infiltration basin.

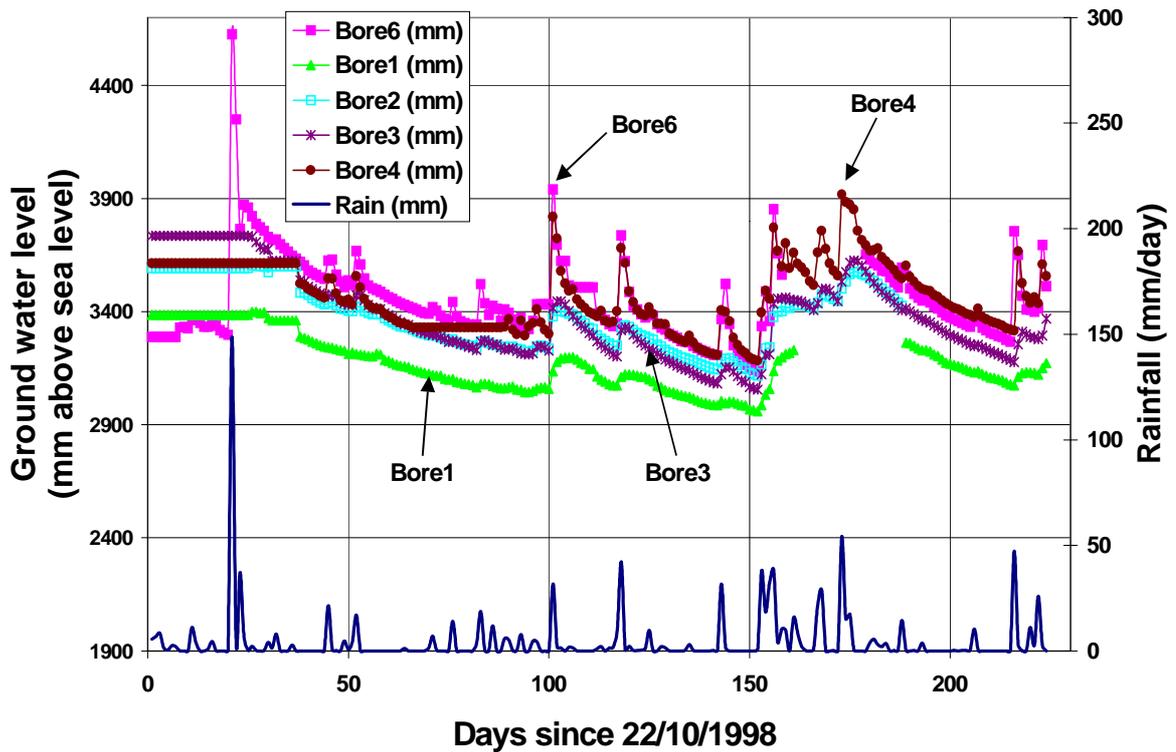
Figure 2.14: Height of water table at all bores

Figure 2.14 shows the relative response of the groundwater levels below Figtree Place as recorded by Bores 1 to 6. The groundwater beneath the site is part of a large unconfined aquifer that moves slowly (about 4 m per year) [Argue, 1997] from Bore 3 to Bore 1. Bore 3 provides the upstream groundwater level and Bore 1 provides the downstream groundwater level. The groundwater levels at Bores 4 and 6 should be between the levels from Bores 1 and 3 because Bores 4 and 6 are between Bores 1 and 3 and are affected by recharge from the infiltration basin. The groundwater levels at Bores 4 and 6 are higher than Bores 1 and 3 (Figure 2.14) indicating that the infiltration scheme has created a localised increase in groundwater levels. The groundwater levels have increased by an average 250 mm above the expected normal position of the water table.

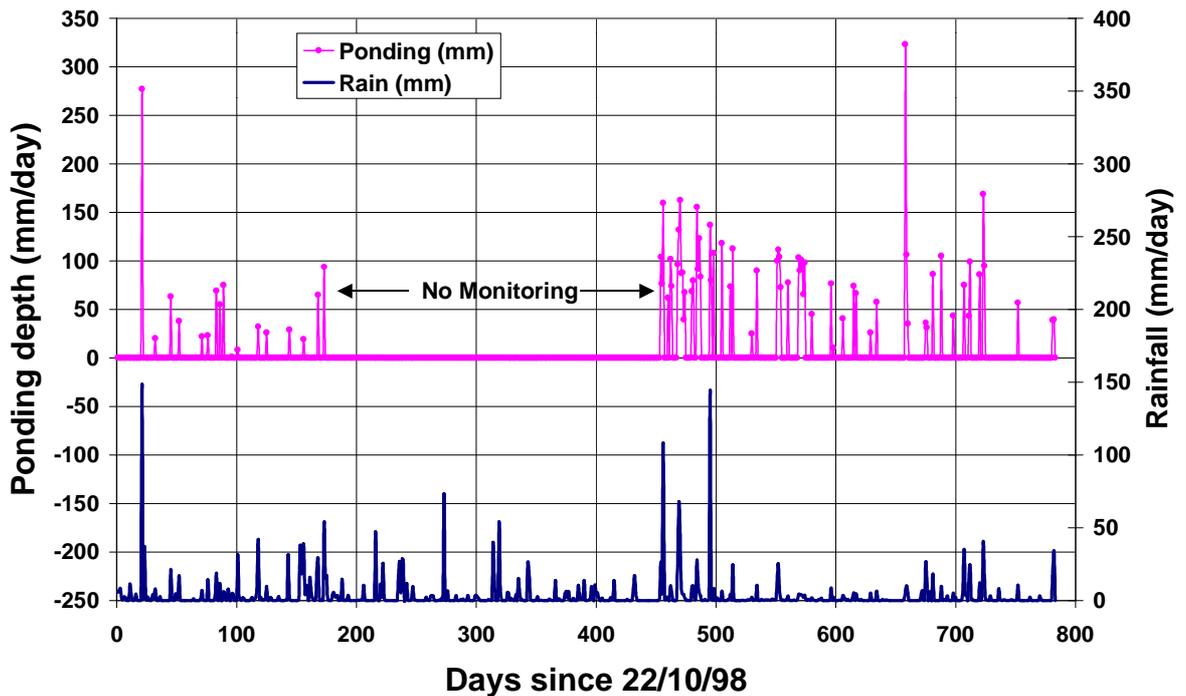
The performance of infiltration basins can be assessed by examining the depth of ponding, emptying time and infiltration rates over a long period [Argue et al., 1998]. The performance of the central infiltration basin is shown in Figure 2.15.

Figure 2.15: Depth of ponding in the central infiltration basin and daily rainfall

Figure 2.15 shows the depth of ponding in the infiltration basin and the corresponding rainfall depth on each day during the monitoring period. Monitoring of ponding depth in the infiltration basin was interrupted by construction activities between the days numbered 174 and 454 (Figure 2.15). During the construction period heavy machinery and materials were stored in the infiltration basin. Stormwater overflow from tank T2 was redirected to the infiltration basin. This is shown in Figure 2.15 to increase ponding depths in the basin after day number 454.

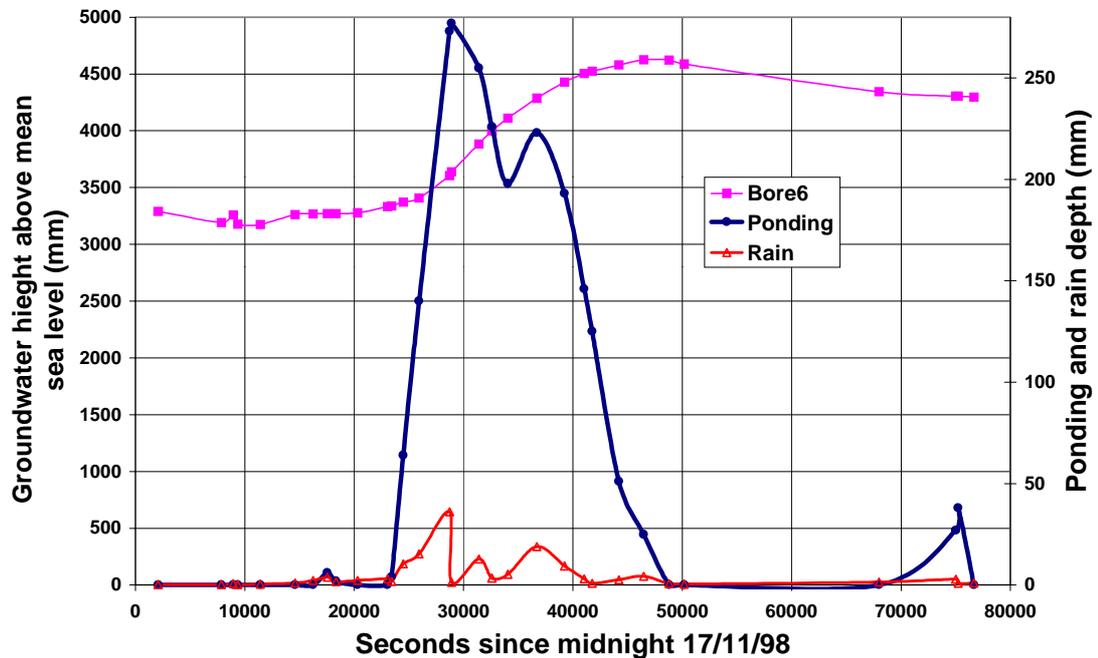
life of the Figtree Place project. Figure 2.16 shows the ponding depth, rainfall depth and aquifer levels during the largest storm recorded during the monitoring period.

Figure 2.16: Performance of the infiltration basin during a storm event on the 18/11/98

Figure 2.16 shows that the ponding depth increased during the rain event and dissipated soon after the event ceased. The height of the water table (Bore 6) below the basin is seen to increase steadily during the rainfall event. A maximum groundwater level is reached soon after the infiltration basin empties and groundwater levels steadily decrease throughout the remainder of the day. Stormwater collected in the infiltration basin percolates rapidly through the gravel base of the basin to the aquifer creating a localised increase in groundwater level. The steady decrease in groundwater level following emptying of the basin suggests that infiltration is causing localised increases in groundwater movement.

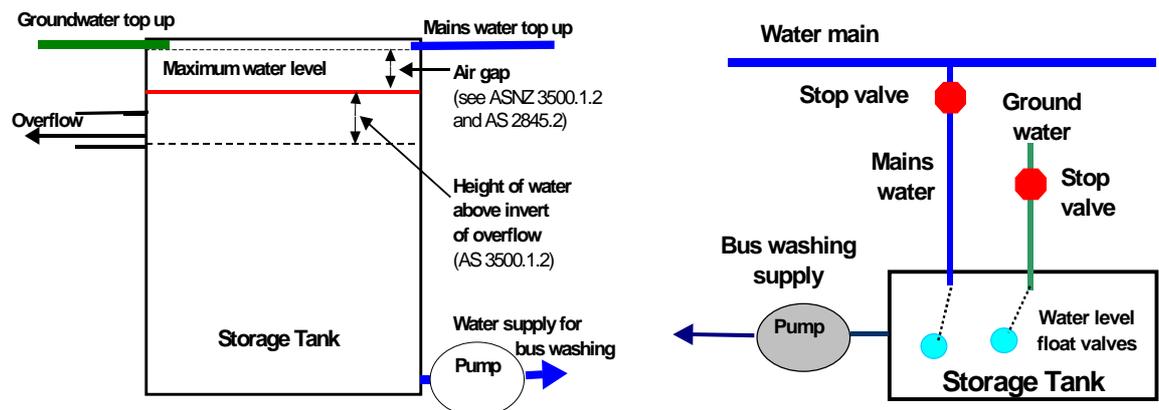
Figure 2.19: Configuration of the mains water and groundwater top up of the bus washing storage tank.

The preferred water supply for the storage tank (Figure 2.19) can be chosen by opening (or closing) the stop valves on the mains water and ground water supply pipes. The water level in the storage tank is maintained at the invert level of the overflow pipe by float valves on the groundwater and mains water supply pipes and a large diameter overflow pipe. When the water level reaches the desired height the float valves closes both the groundwater and mains water pipes with any excess water discharged via the overflow pipe.

The design provides three independent methods for prevention of cross connection between groundwater and mains water. Either of the stop valves can be closed to eliminate the possibility cross connection, closure of the supply pipes by the float valves prevents stored water reaching or entering the pipes and the use of a large diameter overflow pipe provides an air gap ensuring that the stored water does not reach or enter the supply pipes. The provision of an air gap for backflow prevention is reported in AS/NZ 3500.1.2 as acceptable for low to high hazard rated cross connections. However the HWC plumber's disapproval of the groundwater reuse system continued resulting in infrequent utilisation of the scheme.

Unfortunately the reuse of groundwater for bus washing was intermittent due to reconstruction activities and strong disapproval by a HWC plumber. The HWC plumber believed that reuse of groundwater for bus washing was dangerous creating an unacceptable risk of cross connection between groundwater and mains water at the bus washing storage tank [N. Roser, Newcastle City Council, personal communication, 1999]. The storage tank was topped up with mains water or groundwater to supply the washing mechanism. A plumber was commissioned to connect the groundwater supply directly to the storage tank and install an air gap backflow prevention method in accordance with Australian Standard AS/NZ 3500.1.2 Water Supply: Acceptable Solutions [AS/NZ 3500.1.2, 1998]. The solution developed in accordance with ASNZ 3500.1.2 is shown in Figure 2.19.
